## Anthropogenic modifications in the erosional rhythm of a coastal cliff. Rocha do Gronho (western coast of Portugal)

M. Neves

### Abstract

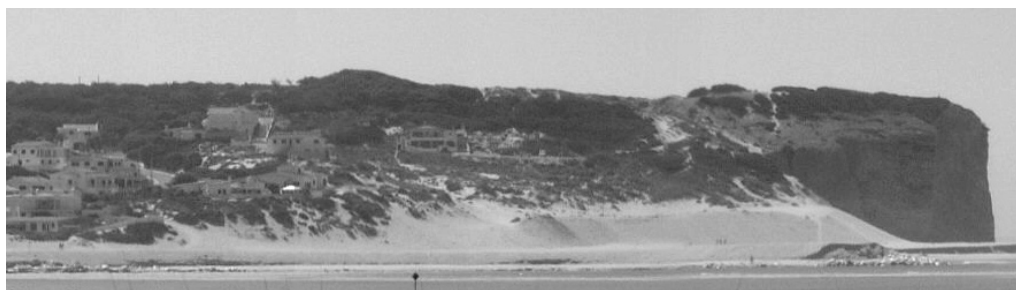
Fig. 2.- A climbing dune covers the Gronho cliff to NE. Remark the village over the dune.

This cliff of Gronho also forms a barrier to the N wind promoting the development of a very high (35-40m) active dune that limits the SW margin of the lagoon’s terminal area. Since the 1960’s, holiday houses have been constructed, partially over the dune, and now form a village of more than 120 buildings (Fig. 2).

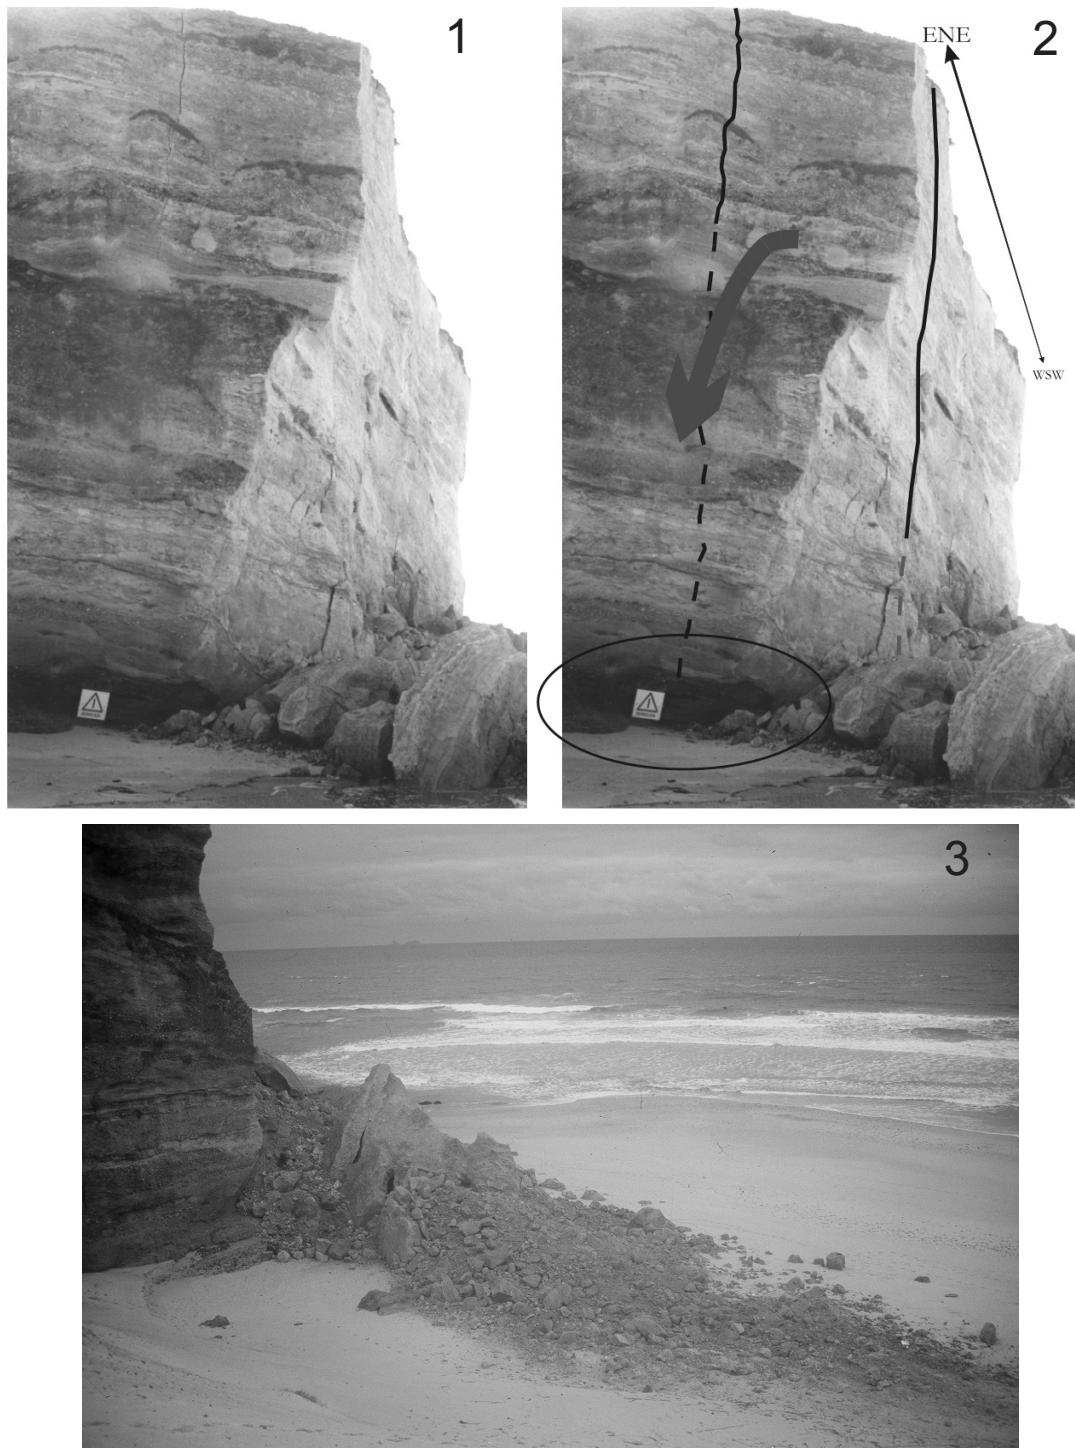
Fig. 7.- ENE sector of Gronho cliff affected by a topple at 14 December 1999. **1 and 2**- Full lines - main fractures; dotted line - probable fracture lines; ellipse - notch at the cliff base; the arrow points out the topple direction. **3**- Photo taken 4 days after the slope movements; the topple debris were dispersed to NE.

In the particular case of the 14 December event, the existence of another discontinuity, transverse to the cliff face, allowed the separation of two blocks. Each of which was affected by a different type of movement. The WSW block was displaced, due to a fall, with the debris cove-

ring the base of the cliff, while the ENE block suffered a topple in a lateral movement relative to the cliff face. The debris from this movement dispersed over an area 63 m in length (Fig. 7). This topple and particularly the direction of the movement was possible because the notch was more profound at the base of the cliff facing NE than that facing NNW. According to Dikau (1996), a block will topple when:

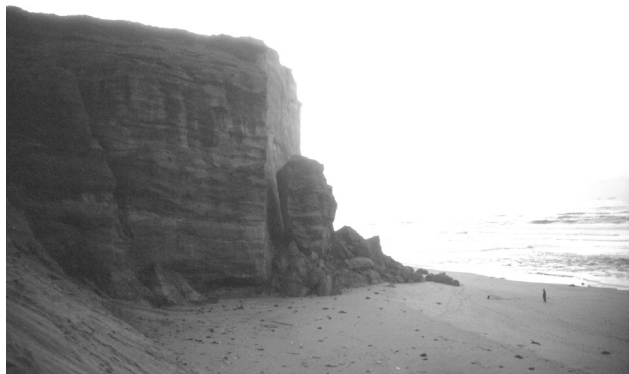
Fig. 10.- Part of the debris produced by the November 2000 rockfall. Photo taken in December 2000.

movement dislodged about 34000 m<sup>3</sup> of rock and affected a cliff-top area of almost 850 m<sup>2</sup> (Fig. 10). In the preceding days, rainfall was scarce and there were no seismic records in the region.

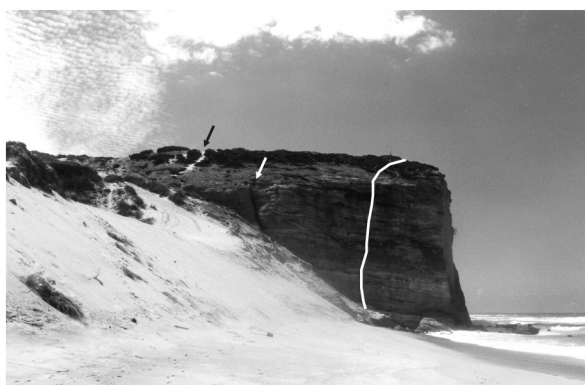
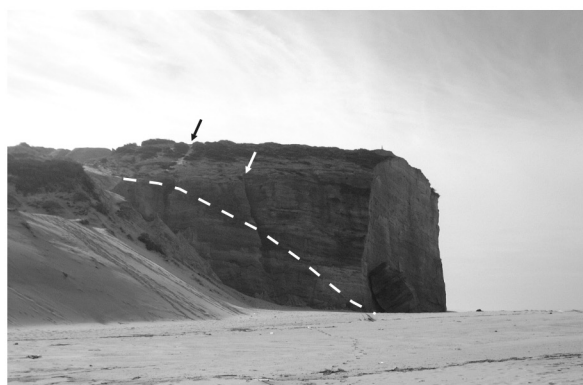
Fig. 11.- Evolution of the cliff and the dune in the fall and the beginning of winter 2000/2001. The arrows point to a common features in both pictures. Full line: cliff face after the November 2000 fall; dotted line - dune front before the erosive episodes of this period. Photos of 24 August 2000 and 17 January 2001.

Storms in December 2000 and January 2001 (with significant waves reaching 6 to 8 m in height for several days; in January, 2 the maximum wave at Sines reached 13 m) remobilized almost all the debris from the previous fall (Fig. 11).

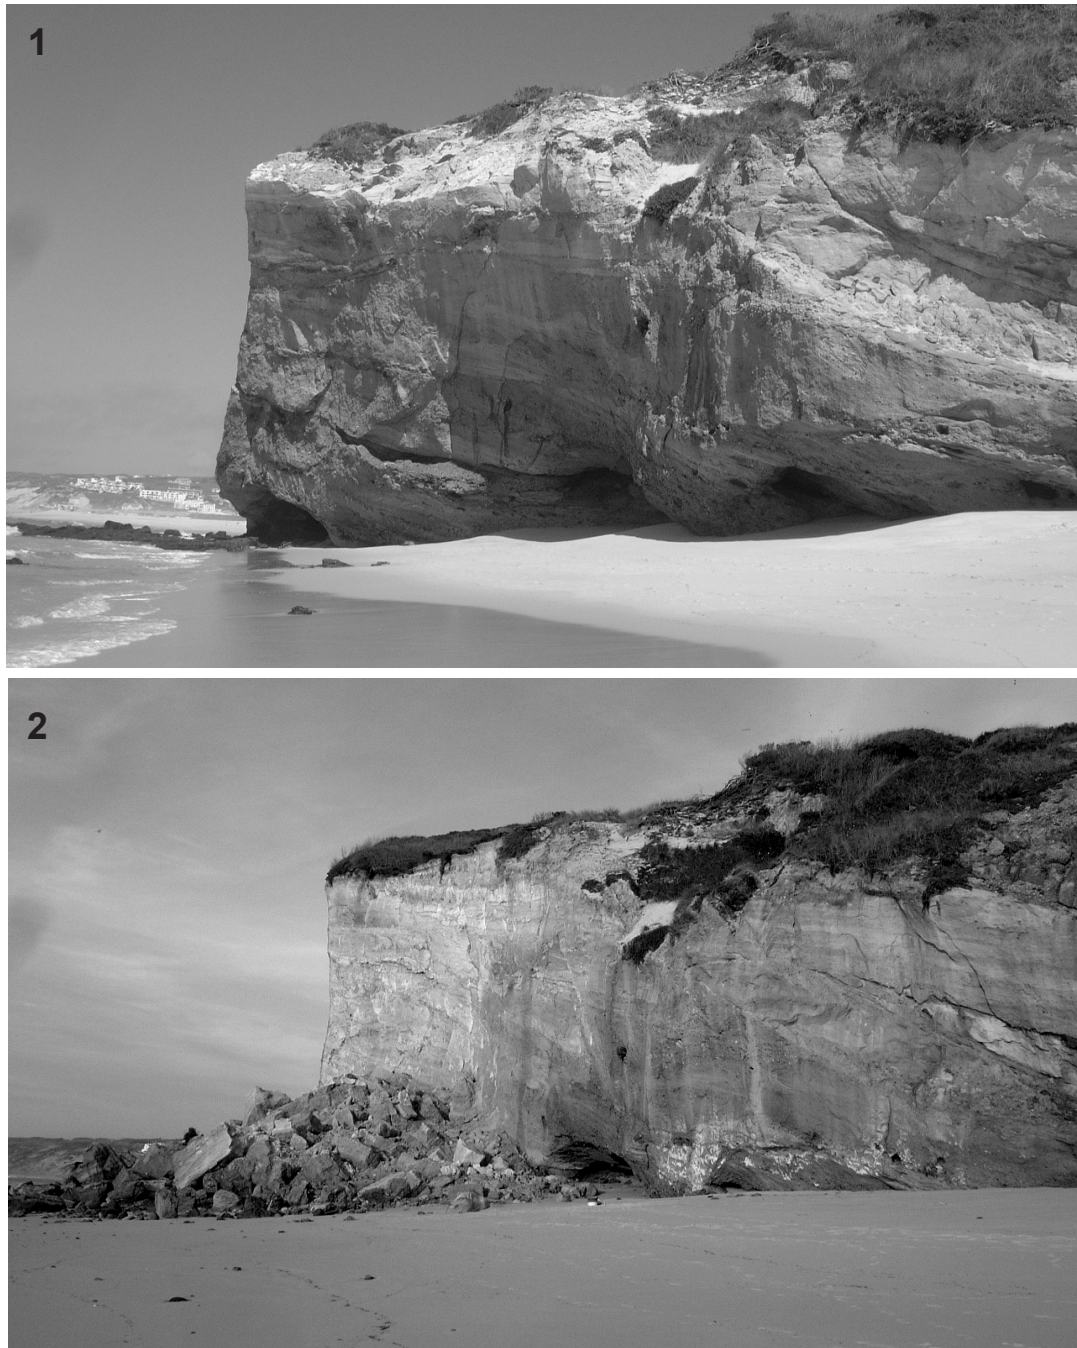
Fig. 12.- April, 1 2004 rockfall. **1**-cliff before the rockfall event; remark the well developed notches at the cliff base; **2**-cliff after the rockfall event (Photo **1**-August 2003; Photo **2** - April, 2004).

Finally, in April, 1 2004, a new fall occurred moving more than  $3000 \text{ m}^3$  of rock from the top of the cliff which suffered a maximum retreat of 5.4 m and lost an area of  $156 \text{ m}^2$ . This fall took place precisely above the deepest notch (Fig. 12).

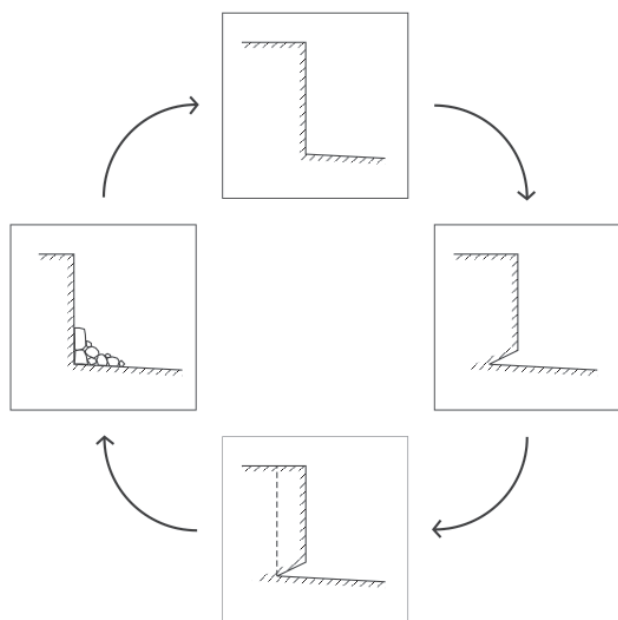
Fig. 13.- Evolution cycle of Gronho cliff.  
Fig. 13.- Ciclo de evolución del acantilado del Gronho.

The situations described correspond to phases of a repetitive cycle that, although with a different rhythm, can be adapted to the rocky coast south of Gronho that is also cut in outcrops of detrital rocks (Fig. 13).

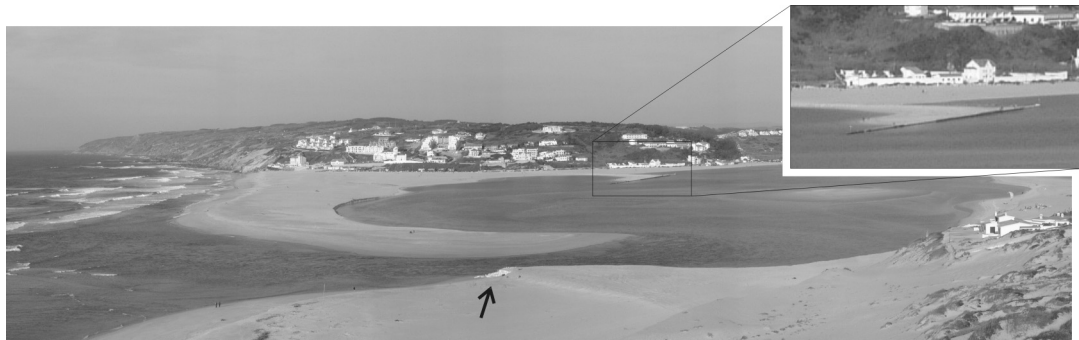
Fig. 14.- The groyne constructed in the Obidos lagoon near its northern margin. The arrow points to the location of the sand bags placed to reduce south dune erosion.

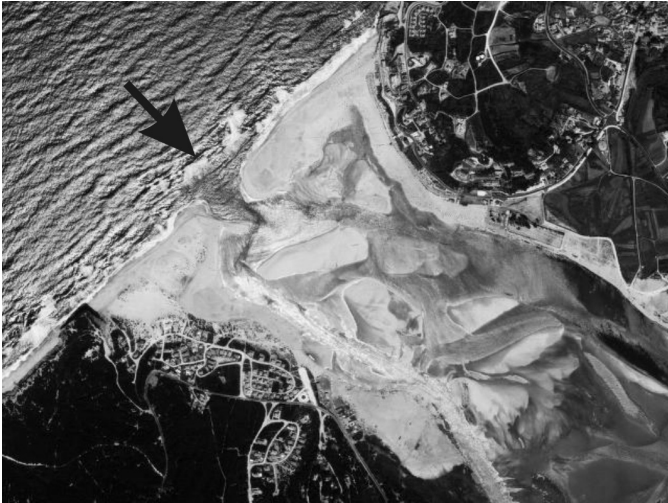
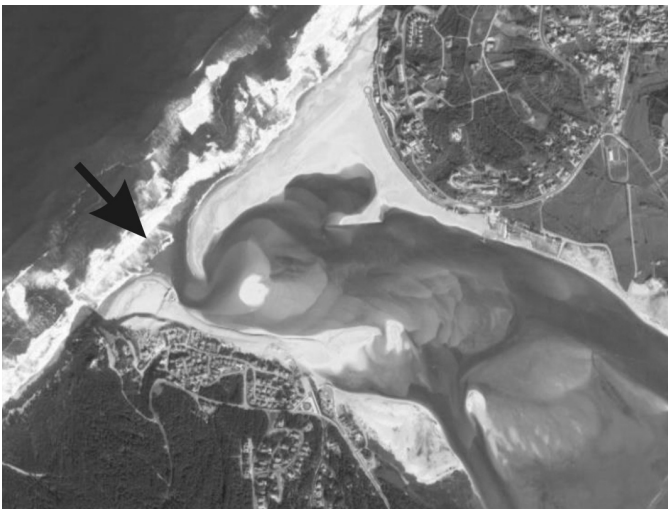
Fig. 15.- Obidos lagoon in: **1**-1995; **2**-2001; **3**-2004. The circle points out the position of the groyne. Note the change to SW in the position of the outlet to the sea.

In the case of Gronho cliff, human intervention in an area close to a coastal lagoon, in 1998, led to a change in the drainage patterns that affected not only the dunes on the southern margin of the lagoon, but also to the distribution of sand at the base of the cliff. As a consequence, the rate of retreat of the cliff grew rapidly in the following two years. The nourishment of the beach in front of Gronho cliff in the subsequent years caused this to decelerate.
